Vision System for Forged Crankshaft Defect Inspection

Gavin Conley, Michael Manfredo, Stephanie Shafer, Marcellus Spinks, Amber Wolgast, Chenxi Wu, Dr. Brian DeJong (Advisor), Ford Motor Company (Sponsor)

Central Michigan University School of Engineering and Technology

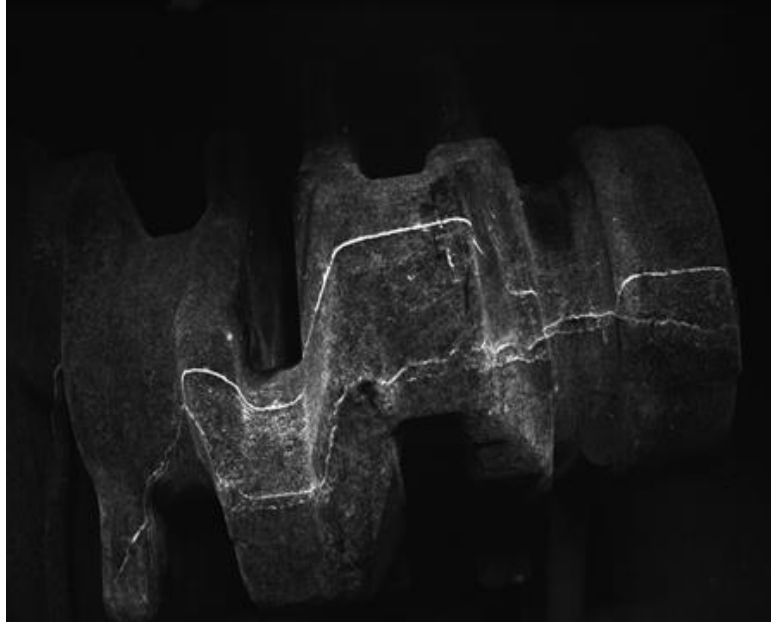
Figure 8. Cognex image from ISM-1403 camera with green filter

The design involved a lot of outsourcing to companies who specialize in certain areas. Several cameras from different companies were tested for feasibility of crack detection, including: Raspberry Pi, MATLAB software, Cognex, and Keyence. Photos from each of the three camera test can be seen in Figures 5 through 9 below.

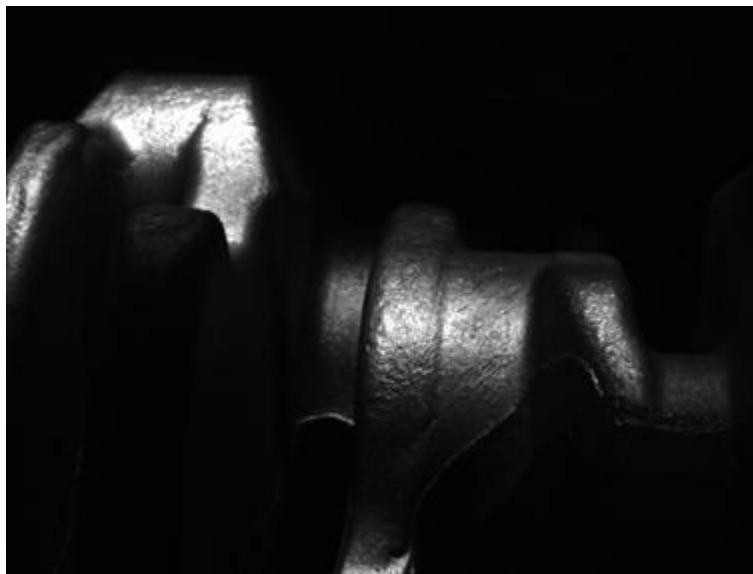
Figure 10. Image without Green Filter (No polarization)

After several exterior vendors were assessed, the team began testing with the loaned Cognex camera and built test stand. To begin, the use of polarization helped the team make progress in detecting cracks on the crankshaft. A polarizing filter is analogous to slatted blinds, in that it “slices” 3D light waves into parallel planes of light. Two of these filters are used. The first, the “polarizer,” does the first slice. If the background is shiny and flat, the parallel planes are reflected as parallel planes. They then pass through the second polarizer, the “analyzer”. The analyzer is rotated in such a way that its slates are perpendicular to the incoming planes. This blocks most of the parallel light. But if the feature is not flat, it will scatter some of the incoming planes, so that some of the feature’s reflected light will get through the analyzer to the camera. The net effect is to reduce the background glare¹. A green filter was applied to the camera in order to negate the green color of the illuminated crankshaft. Any yellow cracks could then be easily identified by the software, as they appeared much whiter and brighter when capturing an image. Examples are provided below of images with and without the polarization filter. Figure 10 shows an image without the applied filter, while Figure 11 shows an image with the applied filter. The filter was loaned by Cognex for the use of this project.

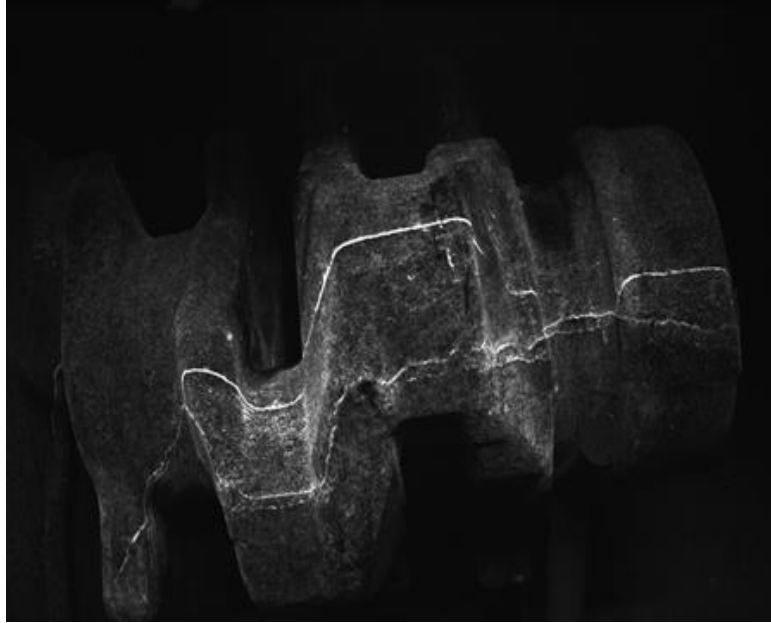
Figure 11. Image with Green Filter (Polarization)

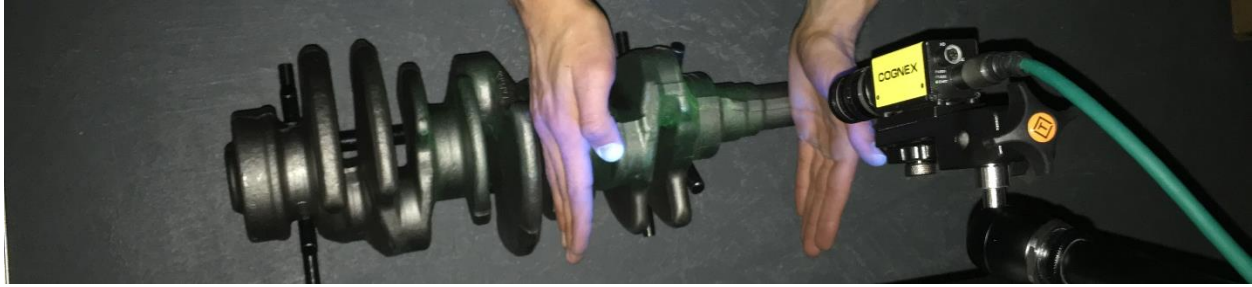
Figure 16. Optimal Length of Crankshaft Covered

However, using the one light the team currently has, the team attempted to capture an image with a cloudy day effect. The team held the UV light on an angle as seen in Figure 13. With the adjustable arm, the team then mounted the camera to the top and captured an image. This provided a much clearer photograph. Figure 15 shows the results of this attempt. The team confirmed that the cloudy day effect is an optimal way of lighting for this application. While completing this test, the team also wanted to document the length of which the camera could cover of the crankshaft to determine the number of cameras needed for this application. Figure 16 shows the image referring to the length covered. That concluded all testing that dealt with lighting. Once testing was underway with lighting and location of the camera, further progress in inspection software could be addressed.

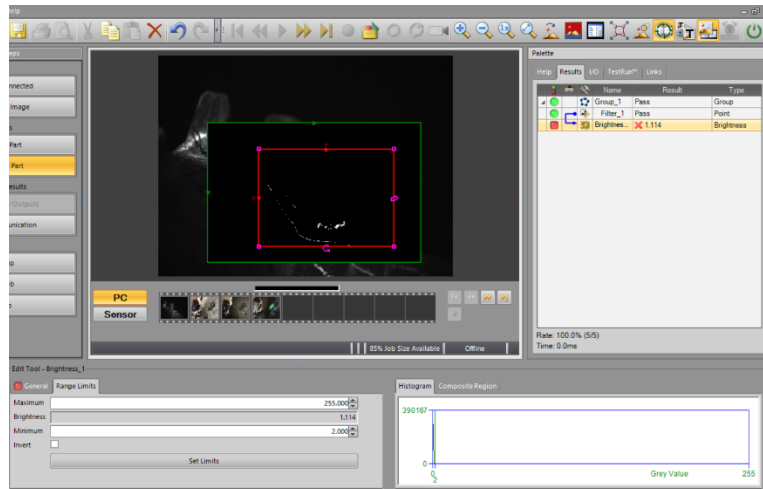
Figure 17: In-Sight Explorer Binarize and Brightness Tools

The current progress of the team is shown below. A Cognex monochrome area camera was pursued for testing because it was loaned to the team for education purposes as opposed to purchasing a camera from another vendor. The Cognex software used is In-Sight Explorer 5.5 and offers the ability to detect cracks through various tools. The two methods that provide the best results are shown. Figure 17 shows an image applied with a binarize filter. This filter works by converting all pixels below a set threshold to black (0) and above the threshold to white (255). A brightness tool was then ran and provided that the image contained a crack. The brightness tool averages out the brightness of the pixels in the window and can be set with minimums and maximums. If the average brightness was 0, meaning all black, there would be no crack present and the part would pass. If the average brightness was anything higher than 0, meaning some white present, then there must be a crack or flaw present and the part would fail. Figure 18 shows the results of a second tool. Again, a binarize filter was used on a captured image, then a tool called surface defects was used to find the crack and output that 13 flaws were present. The surface defect tool works by finding a white pixel, and then grouping it as a flaw if the pixel next to it has a maximum contrast of ± 20 and so on. The number of flaws can be set to say which amount of flaws triggers a crack, 13 triggered a crack in Figure 18. And lastly, the original captured image from the Cognex camera was included in Figure 19. The team is currently looking to use several tools to find cracks contained in one job. Then, depending on how many tools pass/fail the crankshaft, the job will determine if a crack is present.

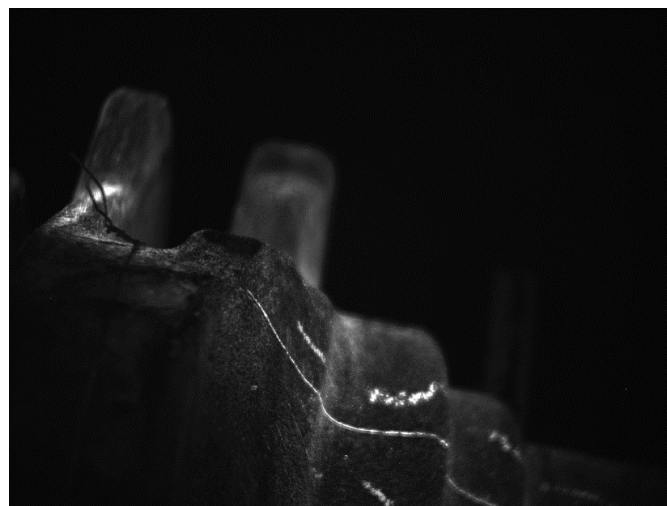
Figure 19: Cognex Camera with green Filter

During benchmarking, Keyence had the most promising software to detect cracks in a forged crankshaft at the initial demonstration. With that thought, the team still pursued other exterior camera vendors to keep options open. Cognex was able to provide the team with a filter and more of an in-depth demo of the software. Not only did Cognex show the ability to see a crack with a green filter, Cognex also showed the team a user-friendly software and interface.
